UNITED STATES ENVIRONMENTAL PROTECTION AGENCY REGION 4

MEMORANDUM

SUBJECT: 2009 GW Monitoring Report for the Grenada Manufacturing Site
FROM: David N. Jenkins, Environmental Scientist
Technical Support Section, Superfund Support Branch
THROUGH: Glenn Adams, Section Chief, Technical Support Section, Superfund Support Branch
TO: Meredith Anderson, RCRA Project Manager
Meredith,

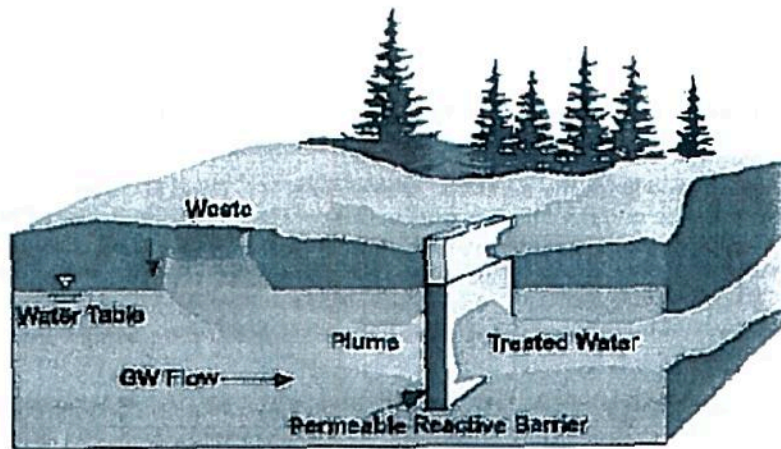
Also regarding the second bullet, the effective life of a PRB wall is commonly 15-30 years. Porosity loss rates can be a few percent per year of the original available volume (Wilkin, R.T., 2005, Long-Term Performance Monitoring of Permeable Reactive Barriers for Groundwater Restoration, EPA ORD Waste Technical Seminar Series, March 2005). As porosity in the wall decreases due to precipitation of dissolved solids passing through the wall,

contaminated groundwater is more likely to be diverted around the wall rather than through it, so a PRB wall may become a dam and may fail to treat the whole plume as anticipated in the design long before the porosity is sealed completely. Without trend graphs showing contaminant concentrations versus time, it is not clear whether the wall will be effective long enough to treat the plume even if all contaminated water were flowing through the wall. Without water level hydrographs and detailed water level mapping, it is not clear whether the wall is in the correct place to capture all of the plume. Without cross-sections through the wall and an evaluation of well screen elevations, wall depth and vertical hydraulic gradients, it is not clear whether the wall is treating all of the plume or whether contamination is going under the wall or around the ends of the wall. (PRB sketch from Wilkin, R.T., 2005, Long-Term Performance Monitoring of Permeable Reactive Barriers for Groundwater Restoration, EPA ORD Waste Technical Seminar Series, March 2005).
